Vale of Evesham Civic Society

Report on Property at risk within Cemeteries and Closed Churchyards

July 2019

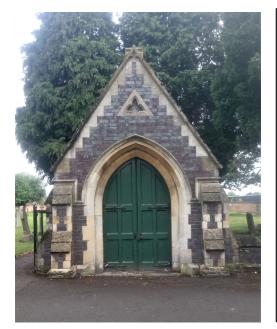
Bengeworth Cemetery, Entrance Lodge—Broadway Road

The entrance lodge seems in fair repair except for the following:

- Three of the four windows are broken. One of them has lost the protective grille and there is a danger of vandalism damage
- The roof shows some deterioration with some tiles either missing or dislodged.

URGENT ACTION REQUIRED

Replace grille on one window.

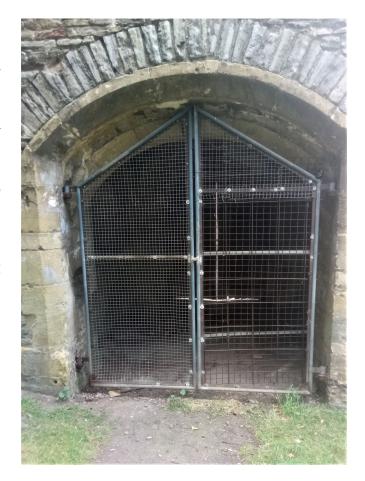
Bengeworth Old Church Remains, Church Street, Bengeworth

The structure has recently been conserved through a joint project between the Town Council and Historic England and is in good condition. However, there remains concern about the grille at the back of the porch as shown below.

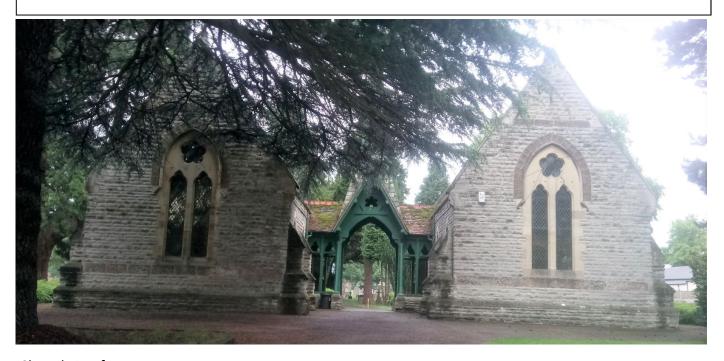
Waterside Cemetery Chapels

The buildings appear basically sound but are in need of maintenance, particularly to the timber structure between the two chapels.

URGENT ACTION REQUIRED

Carry out maintenance on timber structure after specialised survey

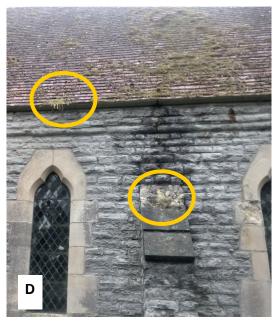
Chapels Roofs

- C. Clearing required. The chapels are surrounded by tall trees and therefore frequent clearing of the roof and gutters is required.
- D. Clearing required. Decayed stonework where shown
- E. Missing coping stone from ridge of roof.

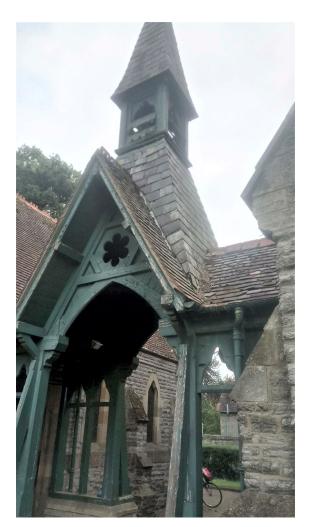
<u>Timber Structure between the two chapels</u>

It is difficult to assess the condition of the structure as it is inaccessible from ground level. However, it is apparent that there is decay in the lower structure, see F and G and the timber needs painting, see H.

It is believed there may be a large crack in one of the chapel walls. To be substantiated. It is suggested a proper survey is carried out by a specialist consultant on both of the chapels and the wooden structure between them.

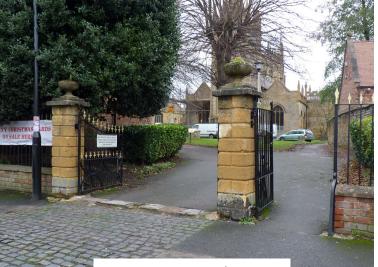
Gateposts, November 2012

The 2012 photograph shows that both finials have gone. It appears that the damage to the RH gatepost by the upper hinge had been repaired using a filler of some kind.

Both gateposts appear to need attention. It is suggested that Historic England are consulted on the way forward.

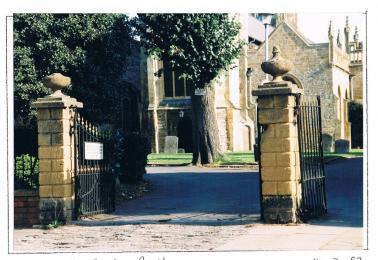
The 1992 photograph shows the LH gate post has lost the finial but the RH gate post is intact. Damage can be seen on the RH gatepost at the upper hinge to the gate.
