**ALMONRY HERITAGE & TOURIST INFORMATION CENTRE
ABBAY GATE
EVESHAM
WR11 4BQ**

Building Survey

Evesham Town Council

This is an update of a previous inspection on 30th November 2017, and includes deterioration of the fabric since then.

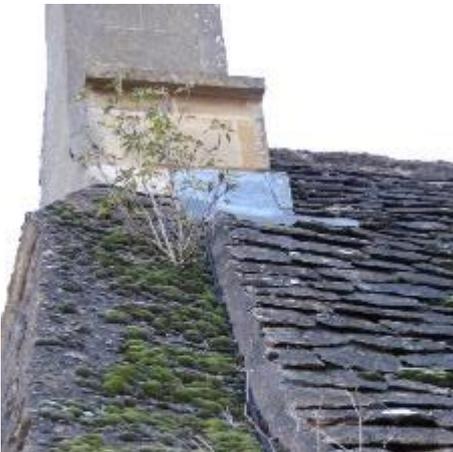
Chimney to north west corner

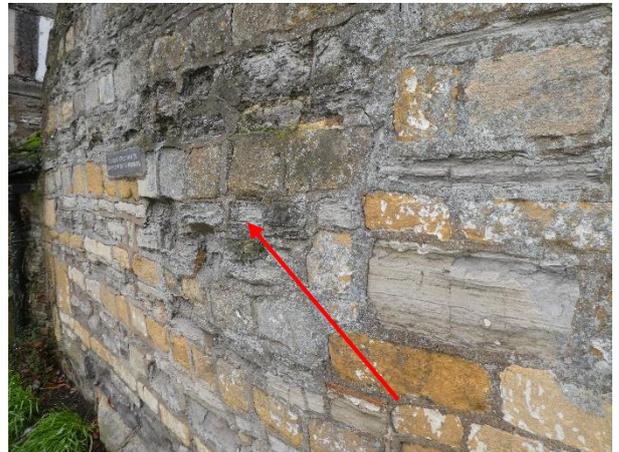
Chimney to north west corner- Stone decay and structural cracking at low level

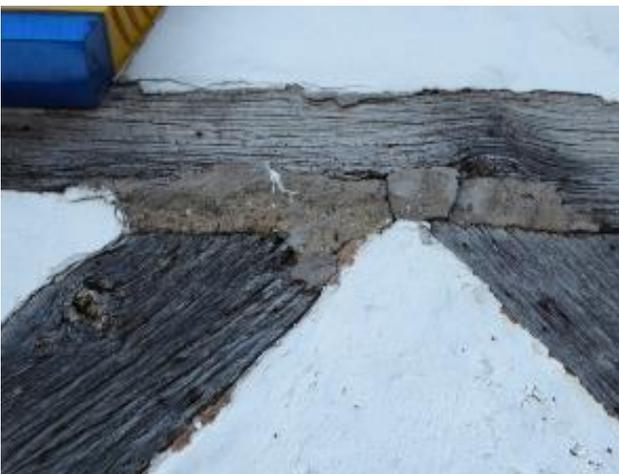
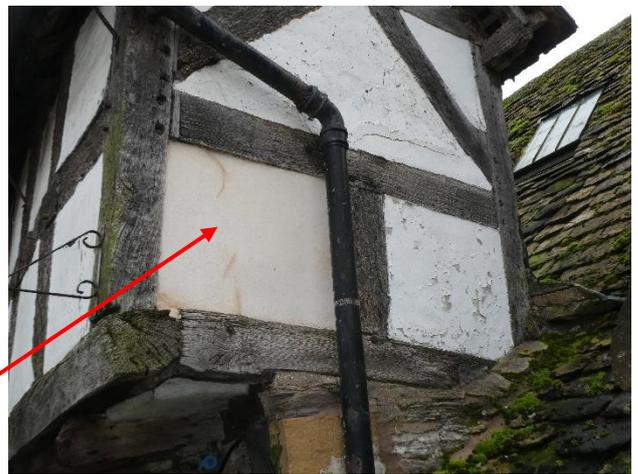
Cement patches to framing- North side

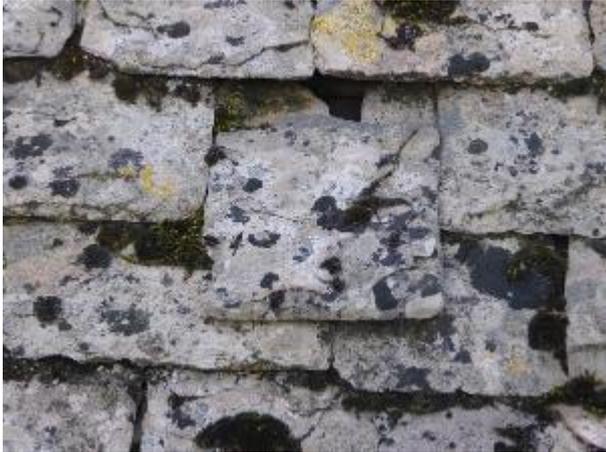
Delaminating and slipping stone slates - North side

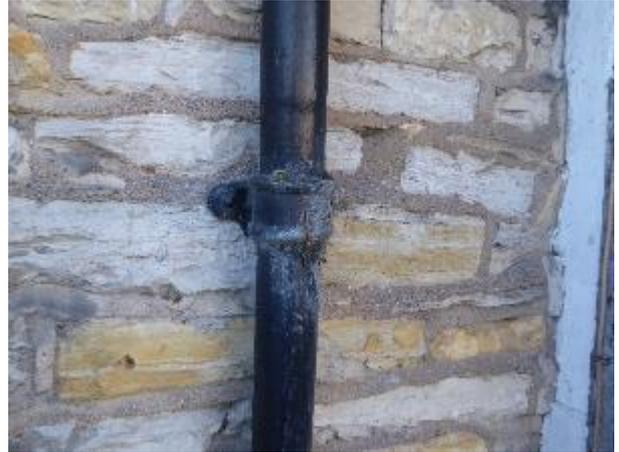
Fractured rainwater pipe - North side

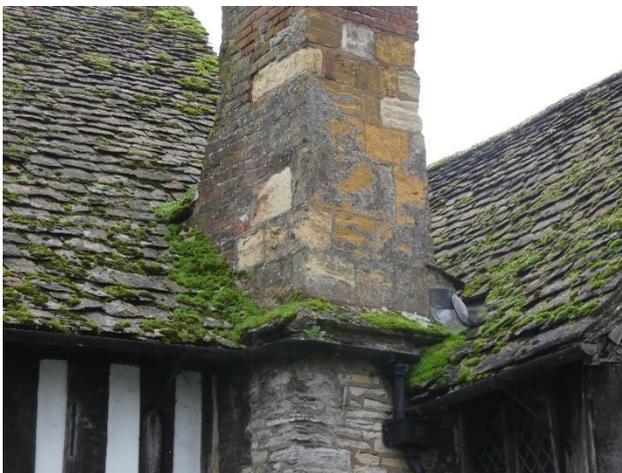
- 1.4.2 Bay to East (Over Victorian Kitchen) - Chimneystack has stone lower part, later brick upper section, probably 18th or 19th Century. Projecting string course to north has weathered away and is no longer performing its function. The top of chimney oversailing course appears to be becoming loose and would need to be inspected and possibly re-set. Lime pointing becoming quite eroded. Some erosion to brickwork on southern side but could not be inspected due to roof slope. Cement flashing to slates, with heavy moss growth.

Chimney stack and roof above Victorian Kitchen.

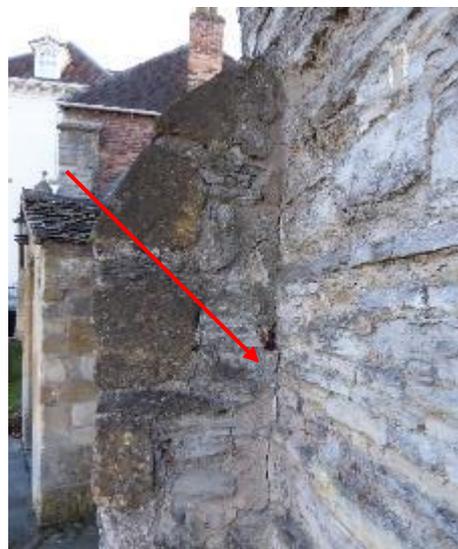
Stone decay to buttress - North side

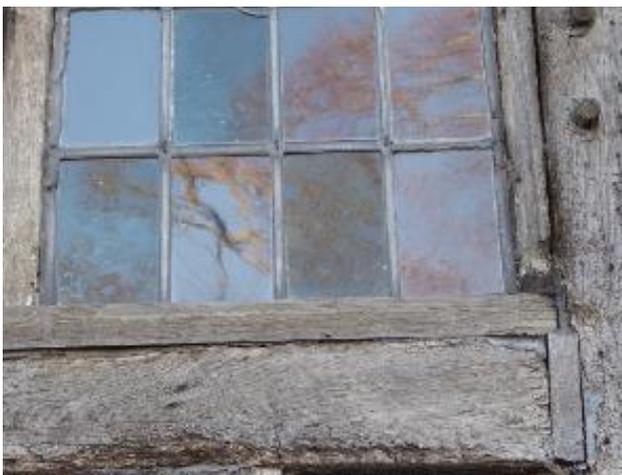
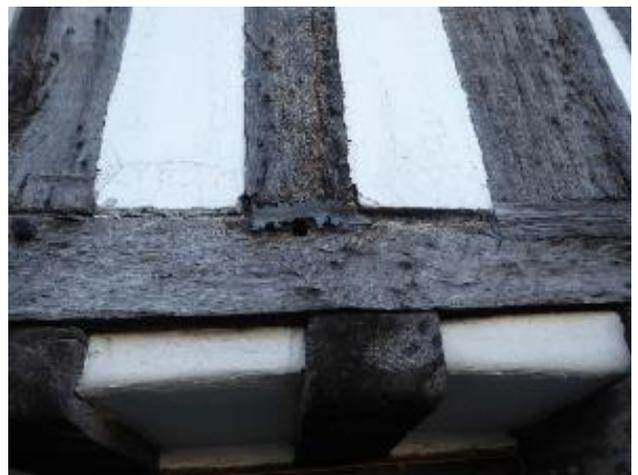
Decay to Archaeology Room window

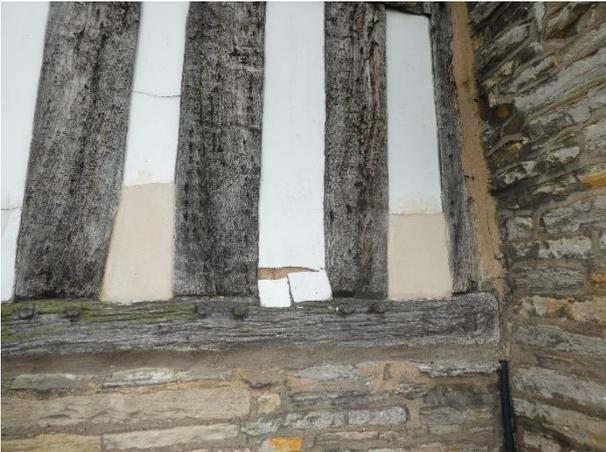
Repaired and failing panels.

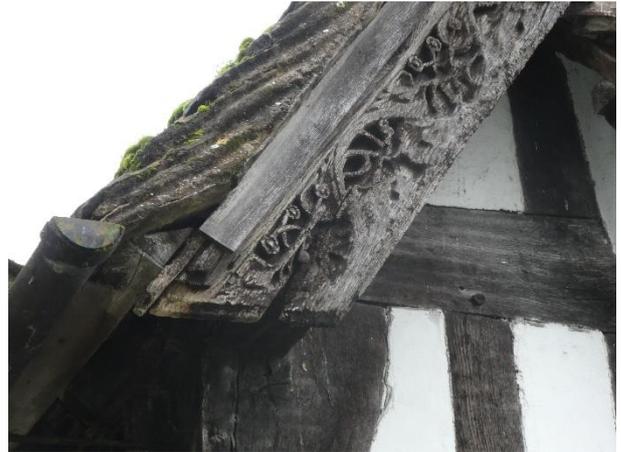
- 4.1 North Elevation - Jettied Upper Storey - To the gable there is a decorative barge board, rather eroded, condition could not be inspected. Appears to be rotting at the base at least. The overhang to the roof shows the timber battens of the roof with no underlining.
- 4.2 South Elevation - Gabled Section to Centre – Decorative oak barge board here has recently fallen off. It appears to be an original, though heavily repaired in the past. About 30% of the two boards appear to be made up of repairs.
- 4.3 Roofs generally have projecting eaves supported on the rafter ends. These have been generally well protected by the roof coverings and appear to be in sound condition.

Decaying original bargeboard to front gable.

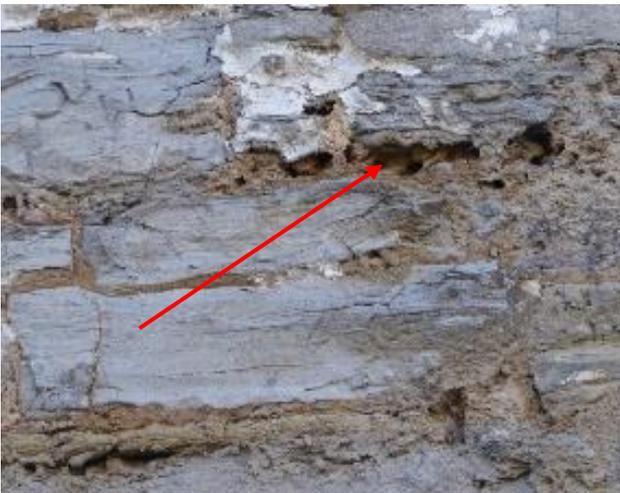
6.6.8 Stone Gabled Section to East - Again, Lias stone, deteriorating quite badly. Generally lime pointed. This is eroding in a number of places with evidence of extensive masonry bee attack particularly at higher level. This seems to infest the central band of almost all the joints and could be destabilising the outer section of stonework. Evidence of old limewash in this section. Buttresses either side with open joints to the weathering of the right hand buttress. Some cement pointing covering cracks where the buttress has moved away from the building.

Masonry bee damage - North side.

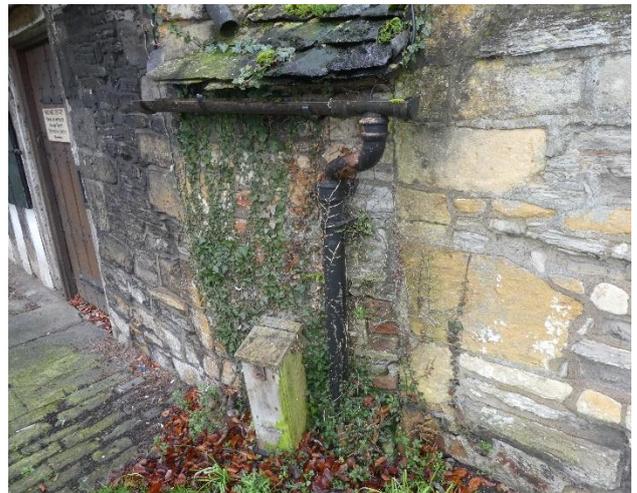
Decaying and possibly blocked downpipe and shaling roof to north side.

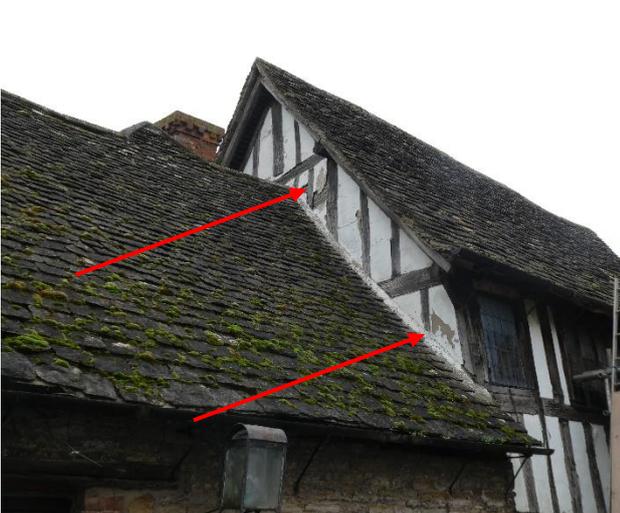
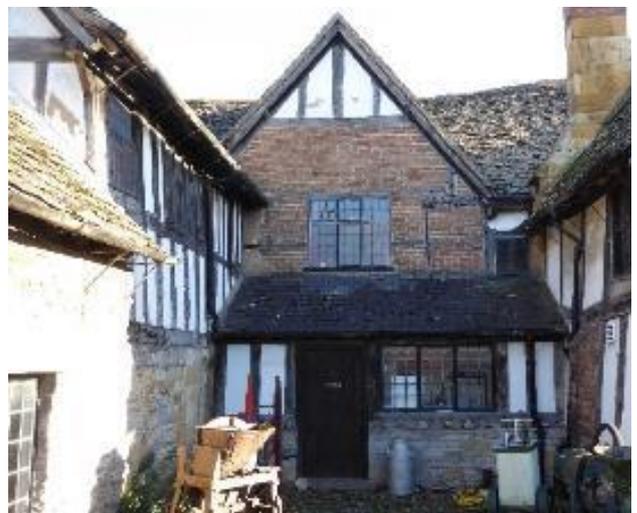
Fallen rendr exposing timber laths above Civic Room.

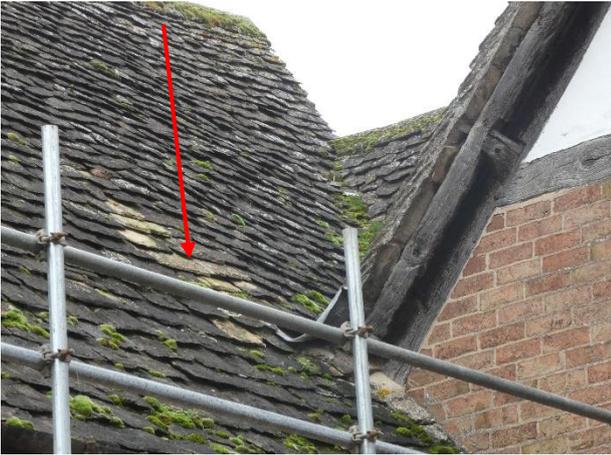
- 2.4.2 Two Storey Section to East - As elsewhere, with a number of slipping slates. A patch of slates recently fell from this roof onto the kitchen Lean-to roof causing much damage. This was in the process of being repaired at the time of the inspection. Also the lead back gutter to the adjacent chimney to the Office wing. Ridge appears to be in good condition.

Recent slate repairs following fall onto Kitchen Lean-to roof.

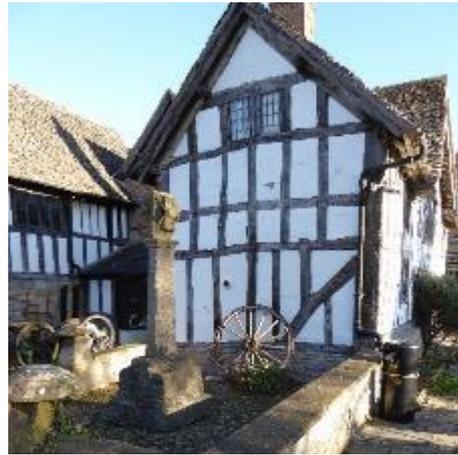
West wall to Office and demolished stable

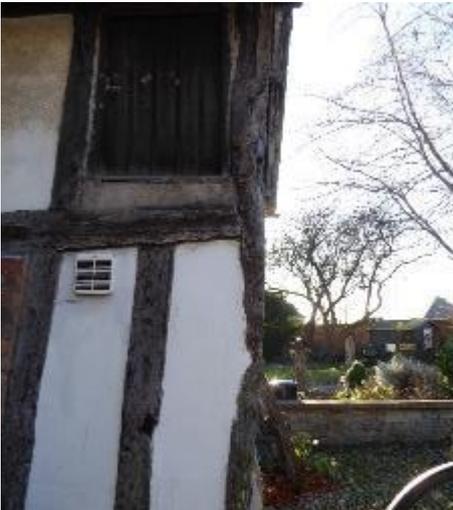
- 6.9 Office Wing
- 6.9.1 North Side - This wing is in the worst condition of any part of the building. Timber framed walls above Lias plinth. Plinth has been pointed in cement and showing signs of some stone damage. Timber framing in very poor condition, many areas of decay visible at joints, also where open mortices have been left and water has penetrated. The frame is notably distorted, leaning by about 300mm to the south-west: this seems to be mainly historic, as a tie bar has been inserted to restrain the gable in the past. There is a curious brick construction in the centre of the wall which appears

Decaying and racking timber framing to Office wing

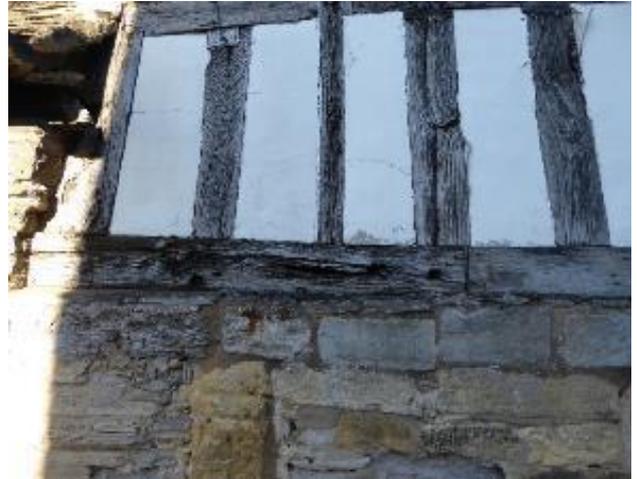
Decaying framing and cracked panels to south main wing

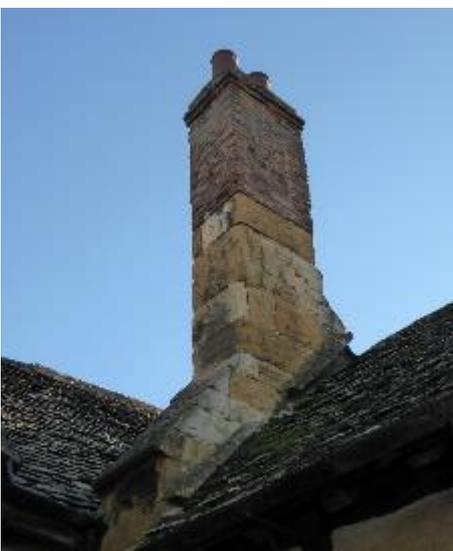
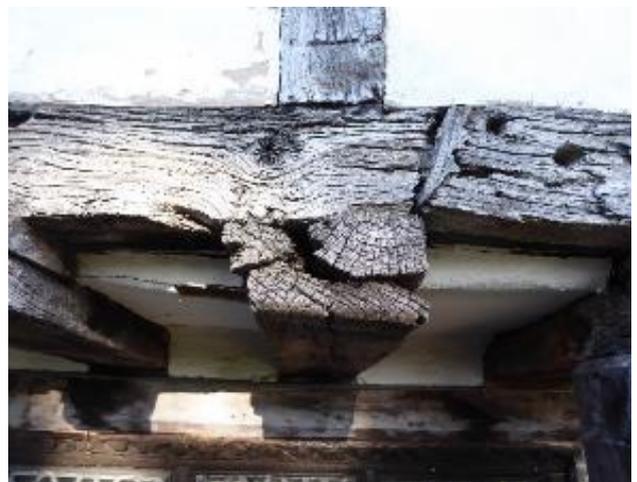
Eroded chimney to Office wing

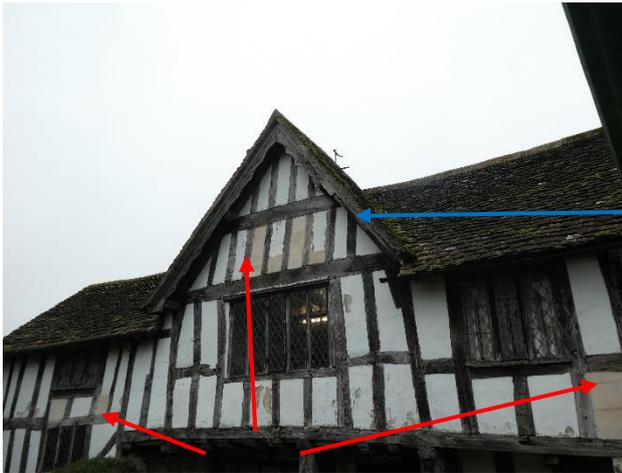
Recently patched panels to south wall following falls.

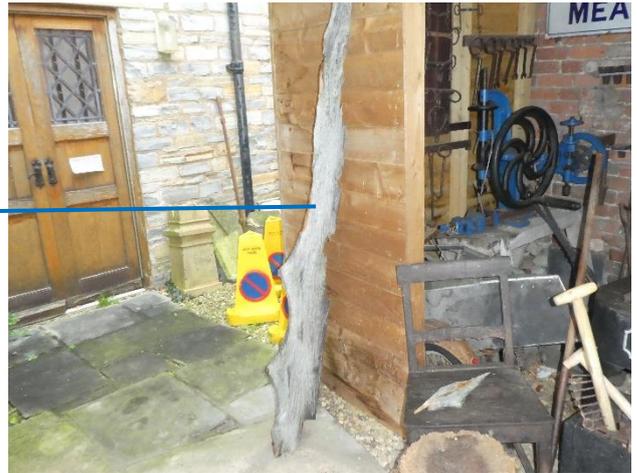
Fallen decayed original bargeboard- former location arrowed.

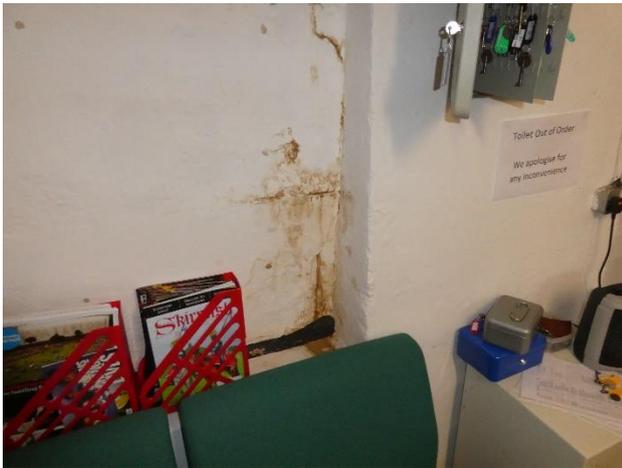
- 3.3 Office Wing
 - 3.3.1 North Side - Rusty cast iron, discharging to a hopper and then a gully. Downpipe was cracked at high level, causing water to leak down on to a timber post below causing decay, and also to floor into the Office. The pipe has now been repaired.

Water damage from leak to Office north wall.

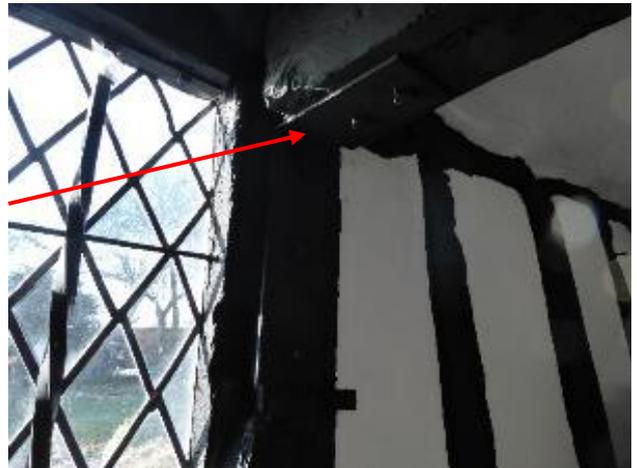
Strapping to Office ceiling beam.

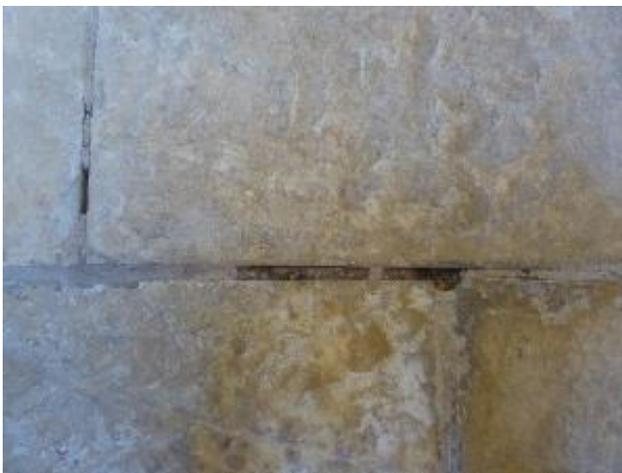
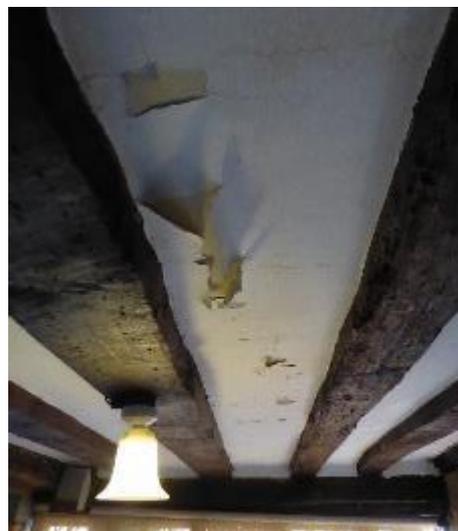
Detail of failing pointing and delaminating slabs to Abbey Room floor

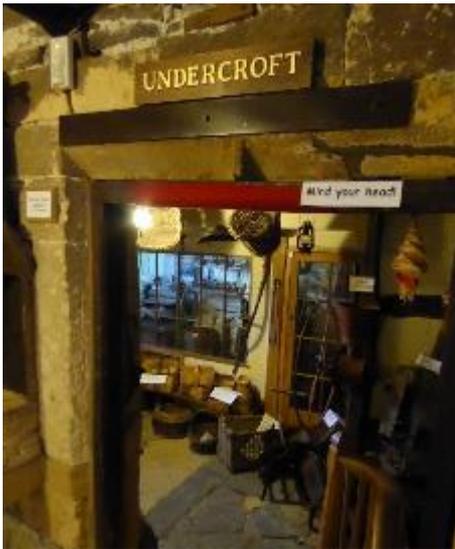
Crude strapping to Undercroft door lintel

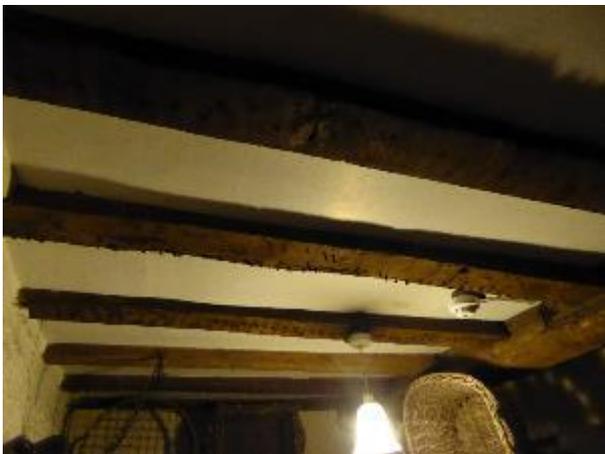
Undercroft Room 1 ceiling - Projecting nails.

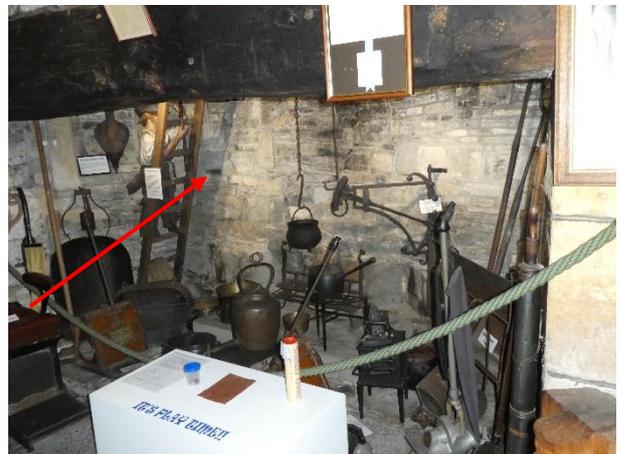
Civic Room Chimney- Tell-tale to cracking to stonework arrowed.

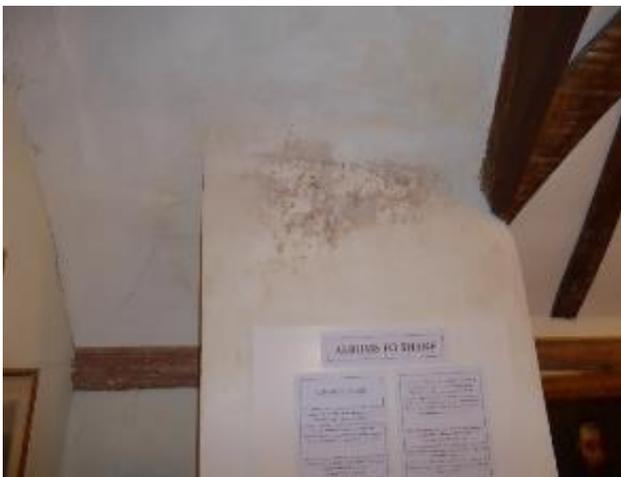
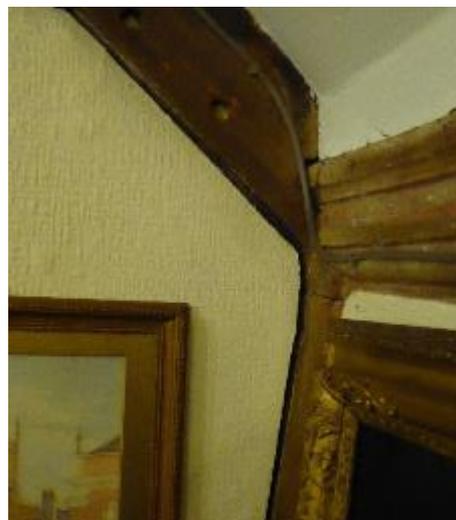
Damage from repaired leaking chimney flashing to Lecture Room.

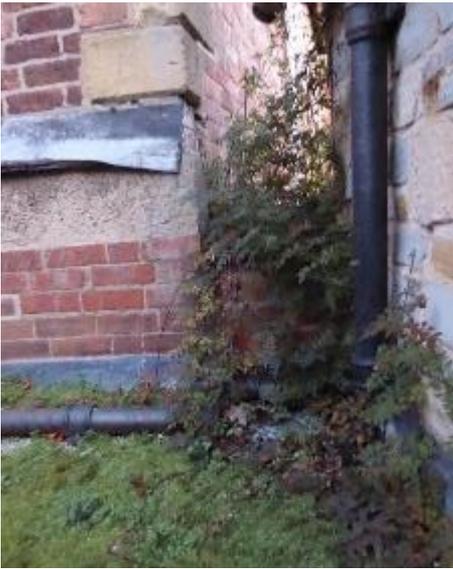
Cracking chimney junction to Lecture Room.

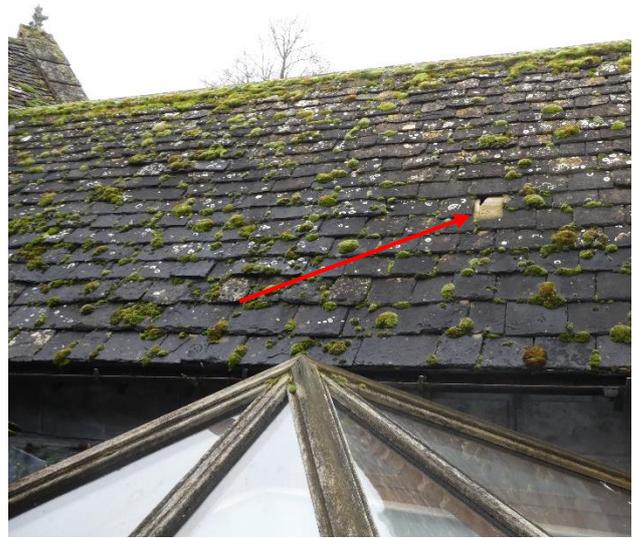
Hole in roof over Tourist Information Centre.

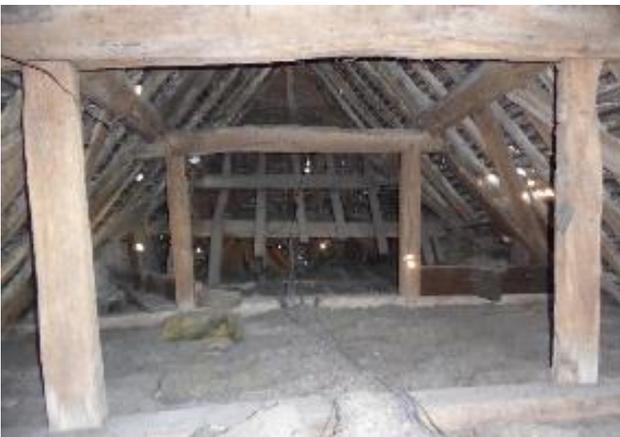
General view of main attic. Note holes in slates.

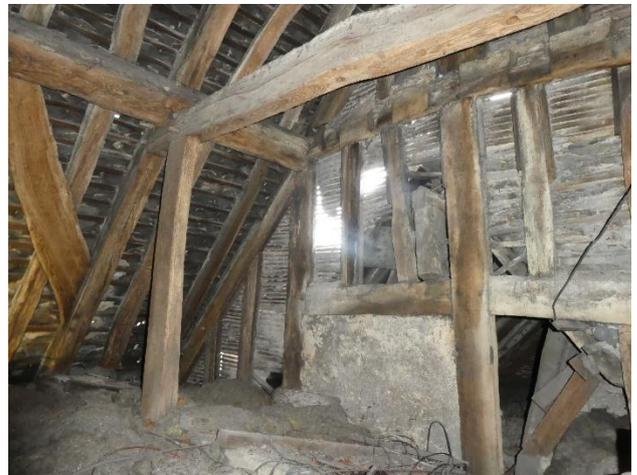
Main attic- Fallen render to west gable forming holes.
