Mechanical and Electrical Services Condition Report
for Proposed Refurbishment Project
at
The Almonry
Evesham

Document Number:	22039-ESDP-00-XX-RP-ME-0001
Purpose of Issue:	Information
Document Revision:	P1
Date:	27/07/2022
ESDP Project ID:	22.039

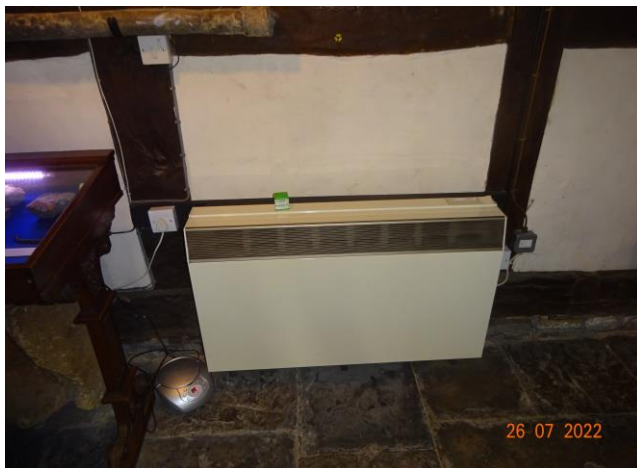
- .01 The building is served by electric storage heaters with a total of 24 No Creda units of various sizes distributed throughout the building. The storage heaters do not provide sufficient heating and In cold weather these units are supplemented by oil filled electric radiators and fan heaters. A previous report measured the indoor temperature at 13°C in the daytime when the outdoor temperature was -2°C.
- .02 It is estimated that the heating accounts for over 85% of the total electricity consumption on site.
- .03 The night storage heaters are aged and inadequate with reports that some heaters do not work and others have limited/no thermostatic control.

Typical Storage Heater

Condition: Poor

- .01 Due to the poor condition of the current heating installation and the rising cost of electricity it is recommended that a new heating installation is provided utilising energy efficient low carbon air Source Heat Pump (ASHP) system(s).

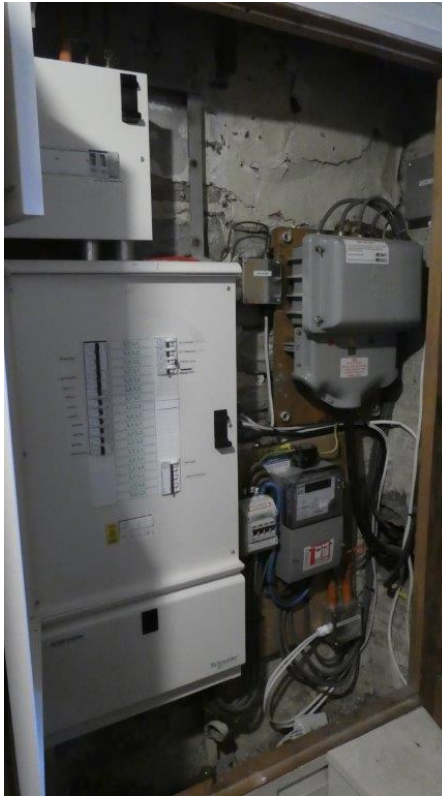
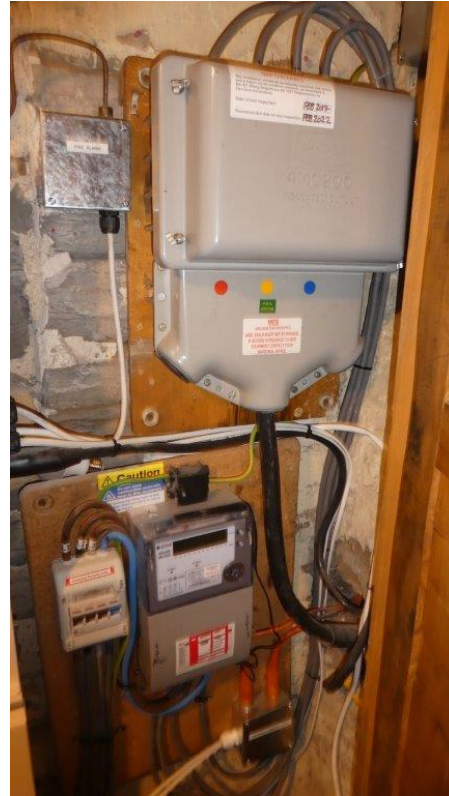
- .01 The building is served by a 100A rated TP&N electric supply with whole current metering, which enters the building from the front elevation into the electrical switch cupboard shown below and serves a new main electrical distribution board which has recently been replaced and fitted with RCBO to some circuits for fire and shock protection.

Condition Good

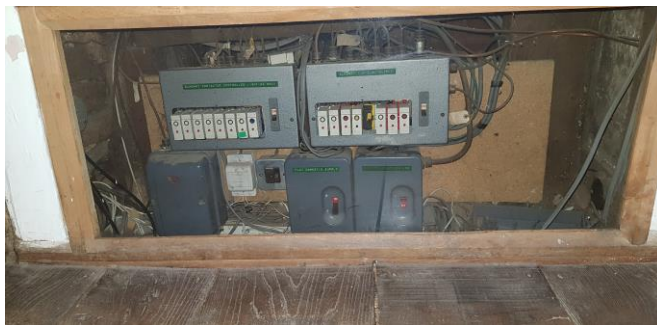
- .02 The main distribution board shown above feeds dedicated single phase and three distribution boards located at strategic points generally in the main switch cupboard and the adjacent display area on the Ground Floor.
- .03 SP&N metal clad distribution boards with miniature MCB's (now obsolete) feed the existing small power and lighting installations. A contactor controlled metal clad SP&N distribution board with miniature MCB's (now obsolete) serve some of the ground floor lighting by a contactor on/off button arrangement located at high level in the display area by a secondary entrance now used as a fire escape.

Condition: Poor

Contactor controlled DB on the left.

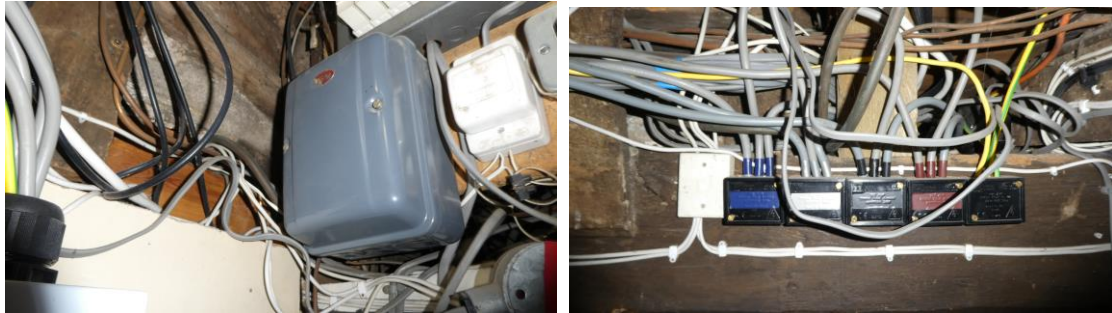
- .05 Final circuit wiring is a mixture of Mineral Insulated Copper Sheathed (MICS) cables and PVC twin & Earth (T&E) routed below the existing floorboards and surface mounted clipped direct with surface mounted metal clad electrical accessories.

Condition Poor

Photos above show the use of Twin and Earth Cabling for final circuits and Junction Boxes to serve the existing distribution board, all which require replacement.
