mortuary chapels
evesham cemetery

condition report
no. 01
dated 29/11/2022

evesham cemetary, waterside, Evesham. wr11 4sb

date of inspection: Monday 28th November 2022

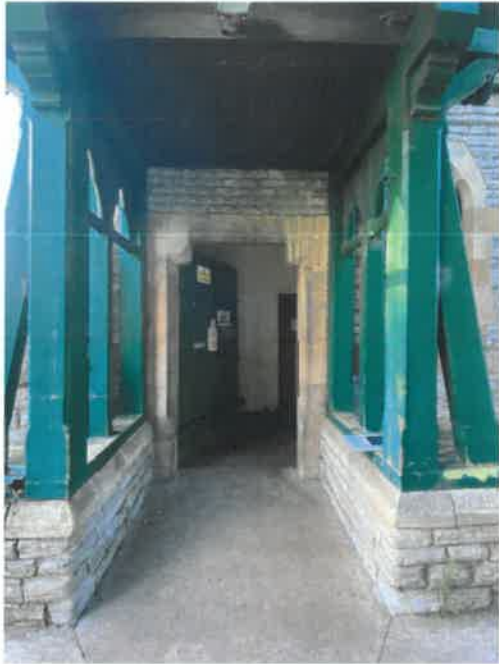
West Chapel east wall ED1 and arcade

- ED1 Good condition except the base of the doors that are showing some sign of rot.
- ED2 Good condition except the base of the doors that are showing some sign of rot.

Redecorate external faces and consider applying a timber weather bar to the base of the doors to shed water off the face of the boards. 2

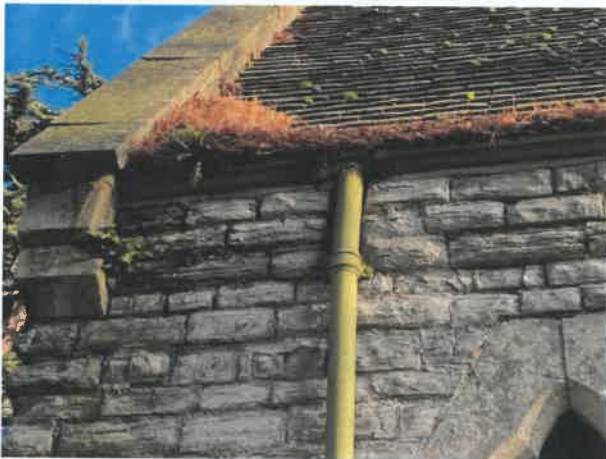
West Chapel west wall gutter

All gutters are full of leaves and plant growth.

Most gutter joints appear corroded and likely to leak – most evident on walls which appear saturated below gutter joints. Downpipes are in better condition

- Clear all gutters of vegetation (this should be done periodically and at least annually). 1
- Recommend replacement of all ogee gutters with new cast-iron to match, with deeper section of the construction allows. 1
- Refurbish half-round gutters and all downpipes with new rust inhibiting systems and new gloss paint finish. 1
- Refit and ensure all joints are tight and sealed. 1

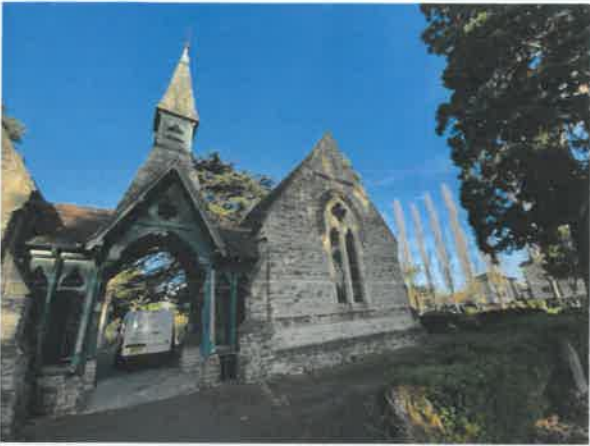
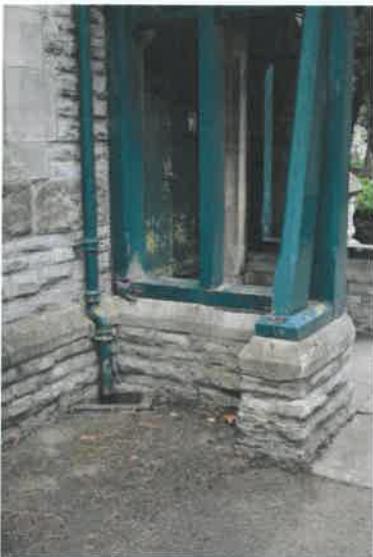
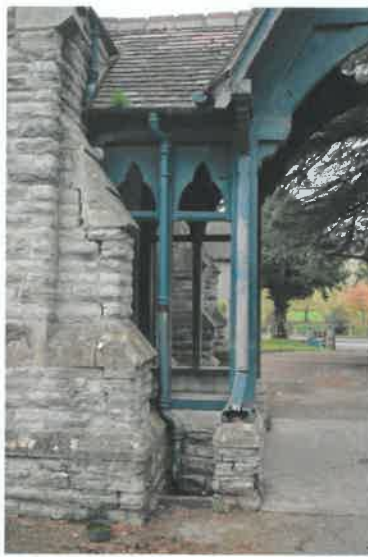
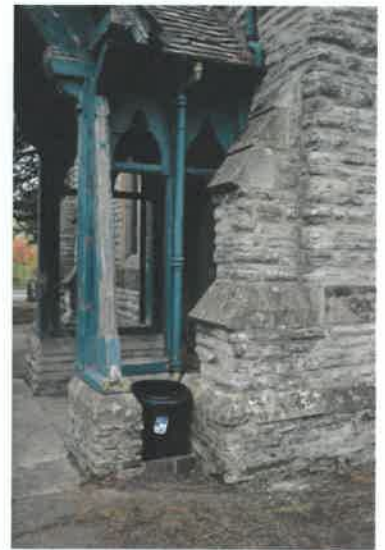
Arcade from south

In poor decorative order but the structure appears sound apart from the south side which has already undergone repairs to the feet of the posts and braces, and sole-plates. The repaired braces are failing and corresponding sole-plates have failed.

- Replace the sole-plates on the south side with new hardwood sections and renew the feet of the braces with new hardwood sections, morticed connections to the soleplate and half-lapped joints to the brace. 1

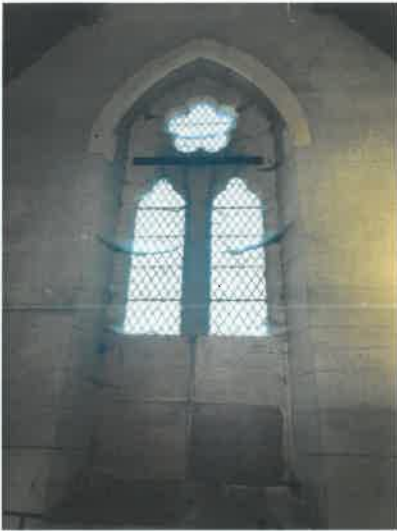
West chapel W5

West Chapel Plaster is generally good but structural movement evident in diagonal cracks around windows, and below W5. Horizontal open joint also evident around the walls at mid-height.

A structural condition report is strongly advised to report on structural movement evident around the building and remedial works that may be required to prevent further movement and stabilise the existing structure.

Rake out and repoint cracks in plaster and monitor for future movement (method prescribed by structural engineer).

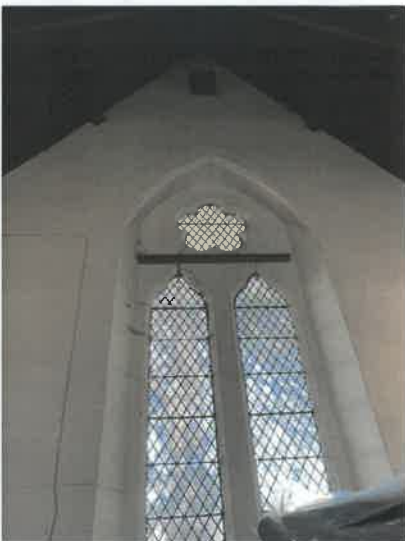
East chapel W10

West wall	<p>Base of central mullion to W10 has eroded.</p> <p>This wall appears to have been repointed at the same time as the north wall.</p>

Limestone surrounds are generally good with some stone repairs required to the base of mullions (W10 and W14), jamb sections (W9 and W11) and rebuild head of window W2.

- Stone repairs to windows W9, W10, W11 and W14. 1
- Rebuild head of window around W2. 1
- Replace missing panes (6 no. noted) and seal base of panels where pointing has failed (4 no. windows). 1

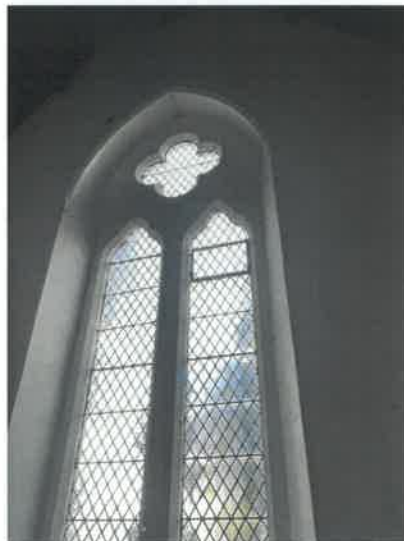
East chapel W14

East Chapel Plaster is generally good but structural movement evident in diagonal cracks around windows and door opening, and below window W14.
