## **Tree Survey**

**Monday 9<sup>th</sup> January 2023**

ProHort Limited have been commissioned by Jo Adams of Evesham Town Council to conduct an arboricultural survey of the land at Evesham Cemetery, Evesham, WR11 1JS. This report details the arboricultural impact of the 5 trees surveyed on the site, subsequent mitigation, recommendations, and protective measures.

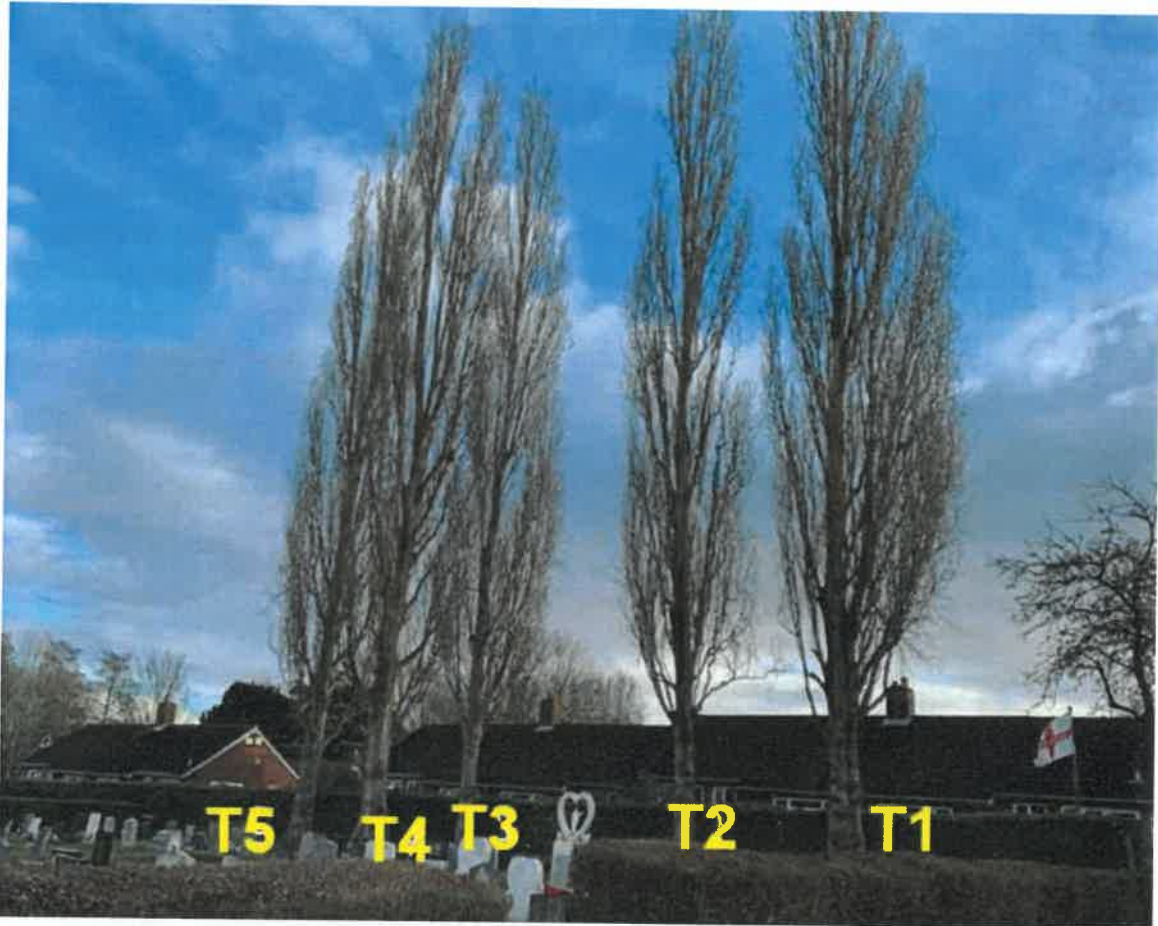
Image 1 – T1 -T5 Showing proximity of the 5 trees to the bungalows on Charles Close

7.2.1 5 individual trees should be removed due to the close proximity to the bungalows and negate liability for the ground heave, possibly caused by the

tree roots. The majority of these are low value. Mitigation for their loss and associated habitats may be required in the form of replacement tree planting.

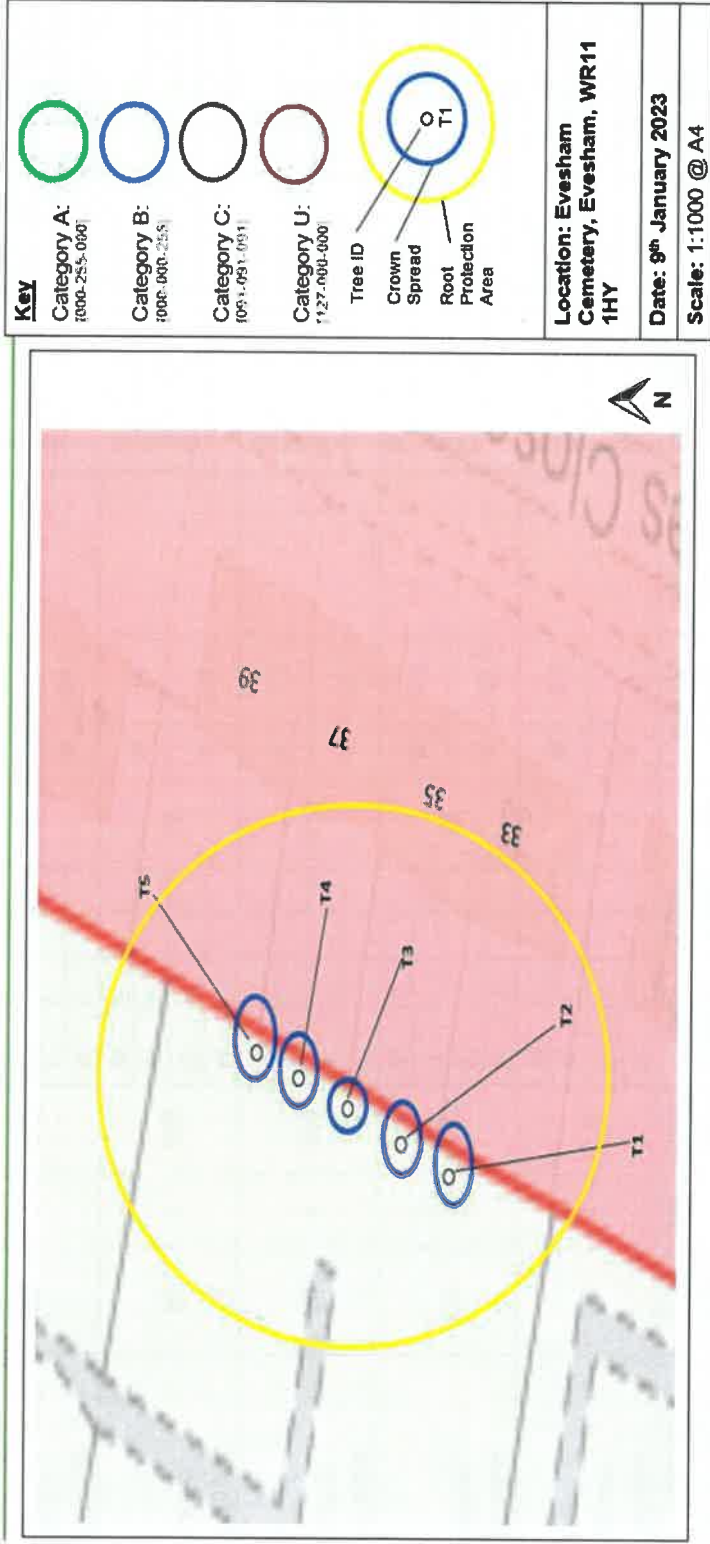
# Site Plan – Drawing 1

A total of 5 Individual trees (T1 – T5) were surveyed and mapped (refer to Drawing 1). All arboricultural information recorded within the survey is presented within Appendix 1.

Scaled plan of the existing Development along with all relevant Trees and Hedges plotted along with Root Protective Zone.

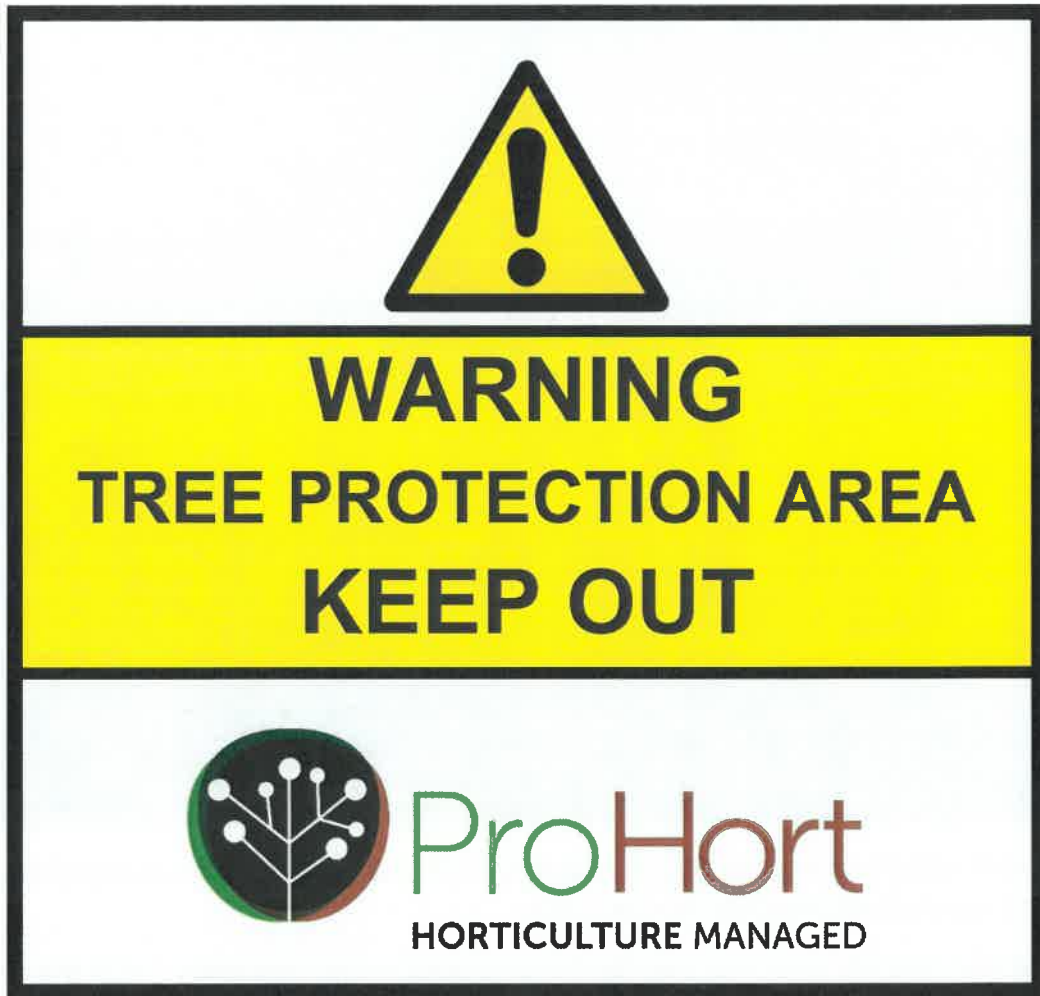
**Appendix 3: “Construction Exclusion Zone – Keep Out” sign**

*This sign must be minimum A4 size and at 1.5 metres above ground level.*

These are not required for the work proposed in this report.
